## **Important Safety Notice**

## SUBJECT: Inclinator Branded Residential Elevators (see below)

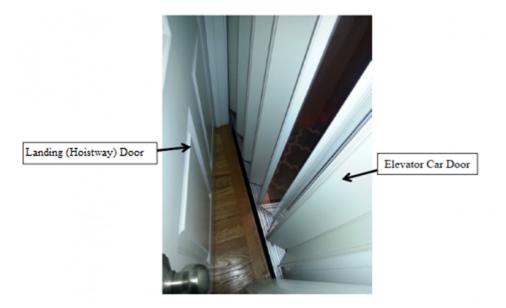
The U.S. Consumer Product Safety Commission and Inclinator are recalling to inspect/repair the following products due to an industry-wide issue involving home elevators installed with an excessive space between the elevator swing landing door (also called hoistway or hallway door) and elevator car door or gate. Although there have been no entrapment incidents with our elevators, **young children can become entrapped in that excessive space and suffer serious injuries or death.** If there is an excessive space between the landing door and elevator car door at any landing, we will provide you with free space guards to eliminate the excessive space.

The above picture shows a Residential Elevator with Space Between the Exterior Swing Landing (Hoistway) Door and Interior Elevator Car (Accordion) Door. A young child can become entrapped if there is an excessive space between the doors.

If your elevator is affected, KEEP UNSUPERVISED YOUNG CHILDREN AWAY FROM IT, and call toll free for a free space guard and installation instructions.
